Planning for failure: creating dental crumple zones

Mark Malterud, DDS, MAGD

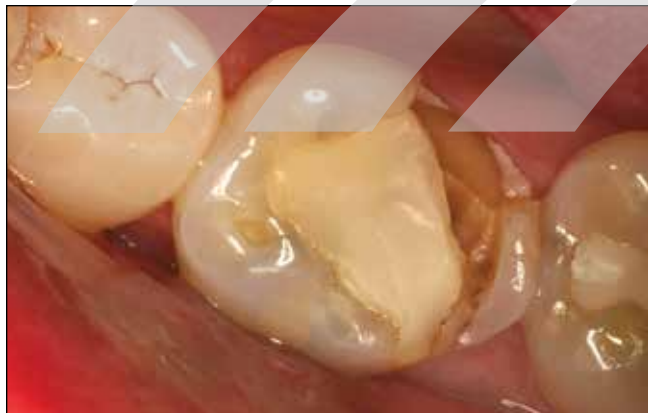
Fig. 1. Preoperative photo of tooth No. 30 showing fracture of the distolingual cusp and loss of filling with decay.

The following case is an example of how MIB dentistry (MIBD) protocols were used in a unique way to restore a severely broken down tooth. The preoperative photo shows a classic fracture of the distolingual cusp of tooth No. 30 (Fig. 1). Both mesial and distal marginal ridges were intact and had no preexisting horizontal fractures in the interproximal areas of the tooth.

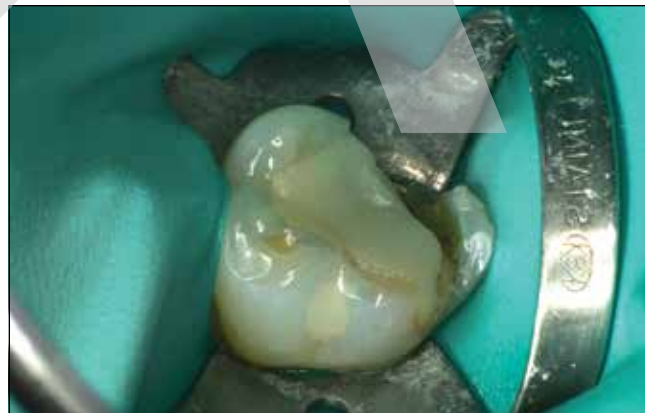
Fig. 2. Tooth No. 30 isolated with a rubber dam showing intact mesial and distal marginal ridges.

Vitality testing of the tooth showed equal response to stimulation as adjacent teeth. The tooth was anesthetized and isolated with a rubber dam to facilitate restoration in a more controlled environment (Fig. 2). The restorative material remaining after the fracture was removed, and the tooth was prepared to receive a bonded direct resin restoration (Fig. 3). There were a number of fractures visible in the tooth that appeared to traverse deep into

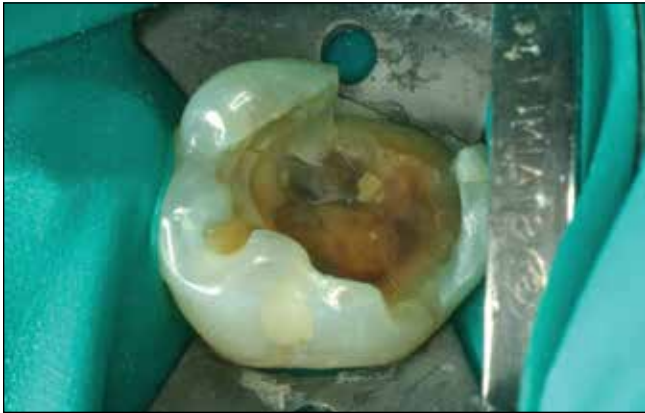
Fig. 3. Tooth No. 30 with all restorative material and caries removed, showing the multiple fractures that will need to be reinforced.

the middle of the tooth, even though the tooth tested vital. As in many of these cases, there was a significant amount of peripheral enamel left of the coronal structure. If a conventional crown was to be prepared in this situation, there would be very little coronal tooth structure left to provide an adequate ferrule effect to create enough retention to hold the crown. Consequently, more drastic measures such as a root canal with a post-and-core restoration would have to be used to retain the crown.

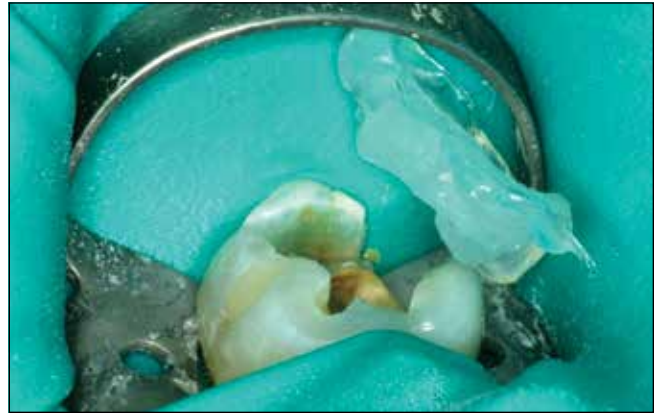
Fig. 4. Clear silicone bite registration fully polymerized after it was adapted to the preparation and then removed from the final prepared tooth.

A clear silicone matrix was created by injecting a small amount of clear bite registration material to the height of the marginal ridges, the material was then compressed into the prepared tooth structure to become intimately adapted to the prepared surfaces. After the clear bite registration stent was fully hardened, it was removed and set aside for use when the fibers are placed, allowing them to be more intimately adapted to the prepared tooth surfaces, with the resin and fibers still retaining the ability to be light-polymerized through the clear matrix (Fig. 4).

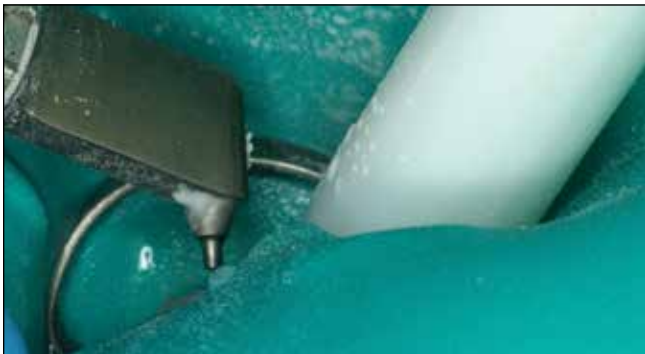
Fig. 5. The tooth is air-abraded to help create a stronger bond of the restorative materials to the tooth.

Finally, the tooth was prepared for bonding with a stream of aluminum oxide and water from a PrepStart H2O unit (Danville Materials) to enhance the bonding (Fig. 5). As an alternative, a fine diamond could have been used to create a fresh surface, but

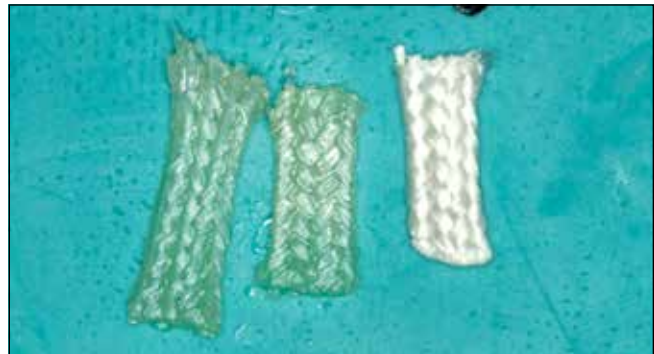
Fig. 6. The Ribbond fibers moistened with the wetting agent to allow better adaptation to the filling materials; the far right one is still dry.

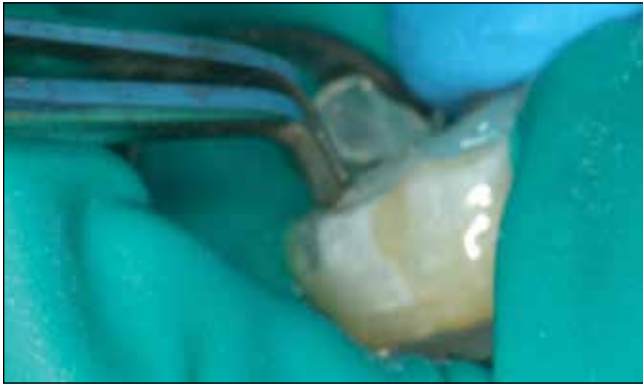
Fig. 7. The clear silicone matrix is replaced to move the fibers intimately to the internal tooth surfaces.

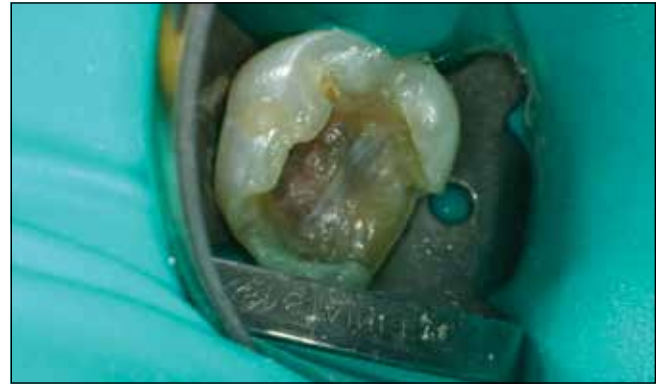
Fig. 8. Tooth No. 30 with the 2 layers of fibers bonded to the tooth structure just before the final restoration of the remaining missing tooth structure.

research has shown that an air-abraded surface creates a better bond.^{3,4} In this case, a fourth generation bonding agent PQ1 (Ultradent Products, Inc.) was used to hybridize the dentin and bond to the enamel, and the bond resin was polymerized to achieve a strong hybridized layer to protect the tooth. An initial layer of low slumping flowable composite (Beautiful Flow F00, Shofu Dental Corporation) was laid down to allow a degree of tackiness for the fibers of the Ribbond Triaxial (Ribbond) to stay in place. The fibers were first wetted with Ribbond Wetting Agent (Ribbond), then adapted intimately to the prepared surface in a pattern that first laid down the mesiodistal-oriented strips, then a second, buccolingual-oriented layer was laid down over the first (Fig. 6). The clear matrix that was set aside earlier was replaced and compressed down over the flowable composite, and the fiber strips and excess flowable composite were removed from the peripheries (Fig. 7). A strong curing light was then shone through the clear matrix to polymerize the bond resin and wetted Ribbond Triaxial fibers. The matrix was removed and the area was final polymerized another 20 seconds showing a tight adaptation of the Ribbond Triaxial fibers to the pulpal floor (Fig. 8). As the excess materials had flowed beyond the cavosurface margins, the margins were redefined with a diamond bur, and all of the surfaces were freshened up with a light stream of the aluminous oxide water mix from the PrepStart H2O. The area was rinsed thoroughly and etched again, not only to clean the resin surface, but also, more importantly, to get a fresh bond to the enamel and ensure the area had been bonded and sealed well.

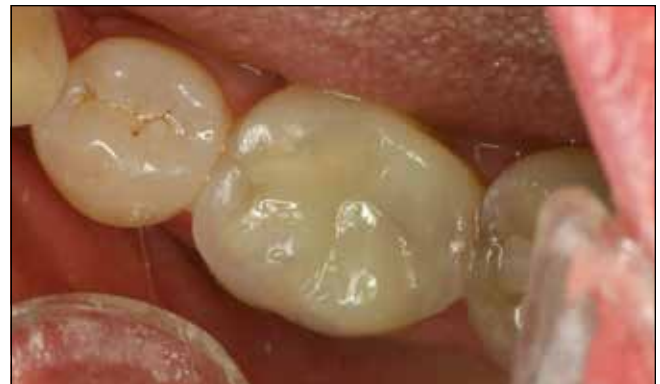
Fig. 9. The final restoration of the tooth to full form, function, and esthetics, along with a predictable mode of failure to protect the remaining tooth structure.

At this point, the tooth was ready for the final restoration. The tooth was etched and bonded, and the final filling was placed with a nanohybrid composite resin filling material, which was placed, shaped, and finally polymerized. The rubber dam was removed, the final contours and occlusion were established, and the restoration was polished (Fig. 9).

Creating restorations that have fail-safe zones built into them protects a tooth from catastrophic failure. Should the patient overstress the tooth with something too firm, the ensuing fracture often times is not completely catastrophic. The fracture is above the fiber mat so that the nerve tissue of the tooth is
